Technical Bulletin

Converting the Lamp Power Supply Voltage

This bulletin provides information on converting the voltage for the D4K, Roadie 4K, CP2230, and CP4230 lamp power supply (LPS).

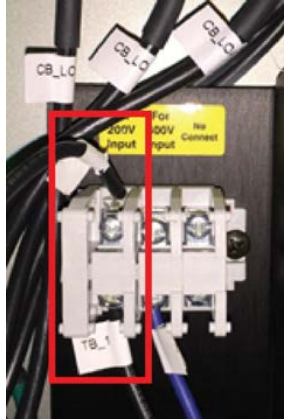
3. Insert the convenience outlet harness (black) wire into the first position on the terminal block.

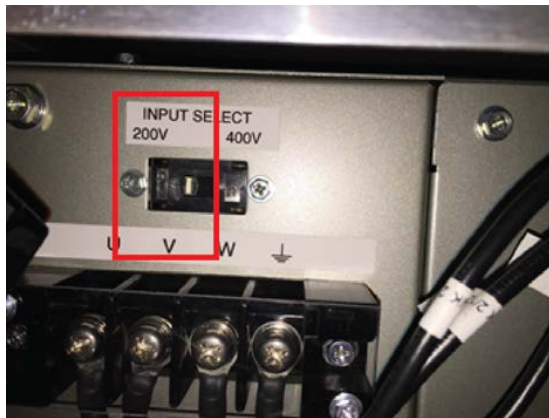
4. Tighten the screw to secure the harness in place.
Ensure the wire insulation is not crimped under the screw.
5. Slide the selector switch to the **200V** location.

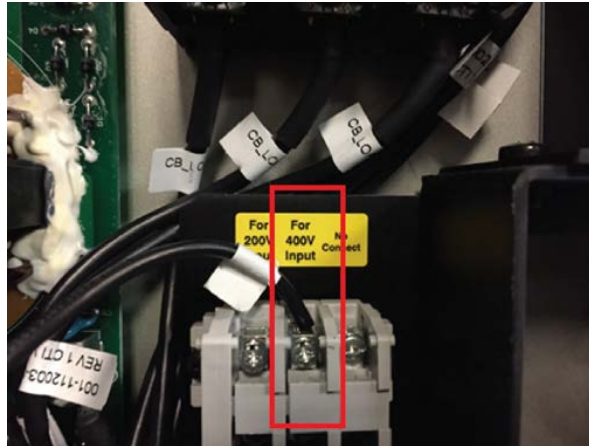
3. Insert the convenience outlet harness (black) wire into the second position on the terminal block.

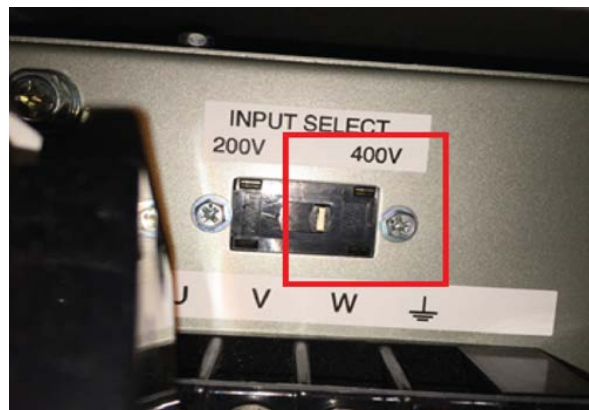
4. Tighten the screw to secure the harness in place.
Ensure the wire insulation is not crimped under the screw.
5. Slide the selector switch to the **400V** location.

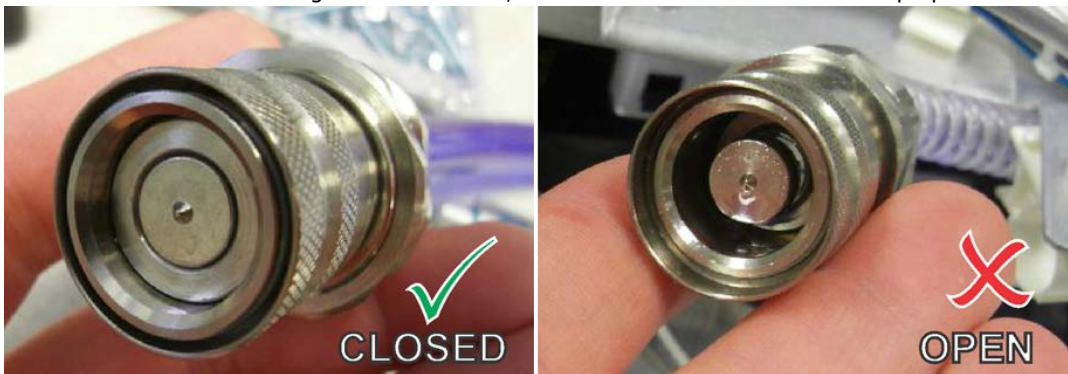
When disconnecting the liquid cooling system hoses, the inner locking ring of the female-side of the quick disconnect may become stuck in an open position (as illustrated below). Coolant may spill and enter the fold mirror or integrator assemblies, which can result in difficult cleanup operations.

1. Position yourself for appropriate visibility of the female disconnect end face.
2. Capture coolant that may spill from the female disconnect (side that the release ring slides toward).

To prevent coolant from entering the fold mirror and integrator assemblies, place additional absorptive cloths on top of these areas. Once the female-side is disconnected, point it upright to reduce the amount of coolant loss if the inner locking ring becomes stuck.

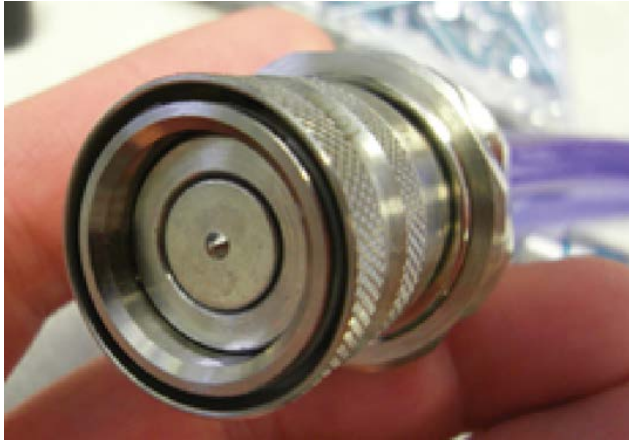
As the female ring releases and moves to its closed position under spring load, it can cause some coolant to be ejected.

1. Immediately re-insert the male disconnect to stop the coolant spill.
2. Wiggle the connection and attempt to disconnect again.
3. If the female disconnect still does not close properly, ensure the coolant has been fully captured and has stopped flowing.
4. Use a soft tipped tool, which can fit inside the connection to press down gently on the stuck ring until it releases and properly closes.

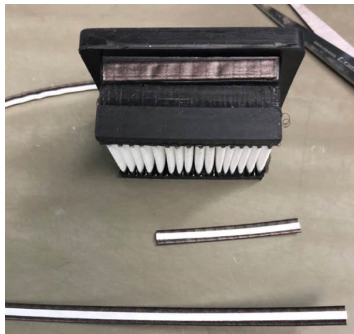
Due to a sizing issue, the LAD filters do not have a proper seal, which could result in the filter catching unfiltered air or dust. Christie is aware of this issue and is working to release new filters.

1. Add a strip of one of these gaskets to the filter as shown below.
 - Gasket foam EMI 1 mm x 5 mm x 24.70" (P/N: 39-001840-01P)
 - Gasket foam 1 mm x 5 mm x 9.5" (P/N: 39-001840-04P)
