RP4.201 of NEC Series2 Cinema Projector adds new capabilities and corrects the issues below.

1. For NC1200C/NC2000C/NC3200S/NC3240S/NC900C series

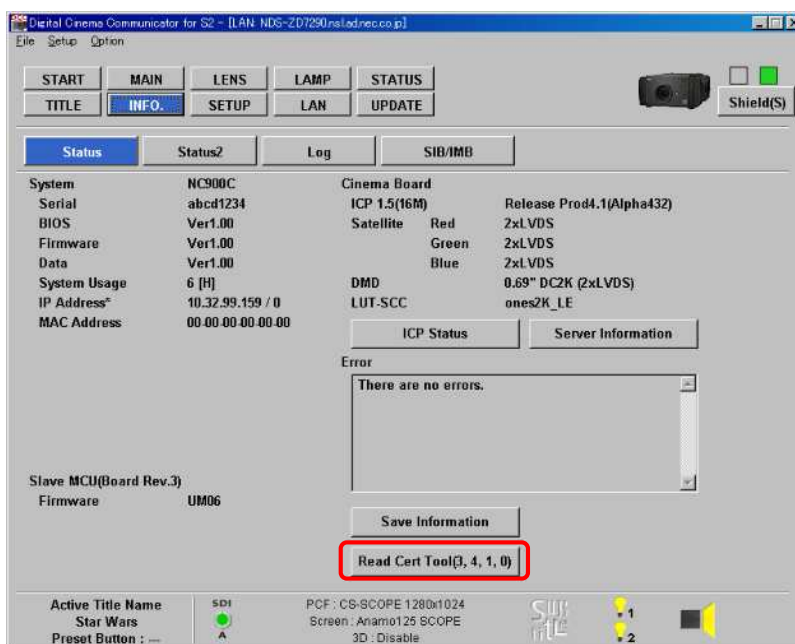
When click on [Read Cert Tool] button, next folder tree dialog shows up.
So please select the destination folder to upload the CSV file.

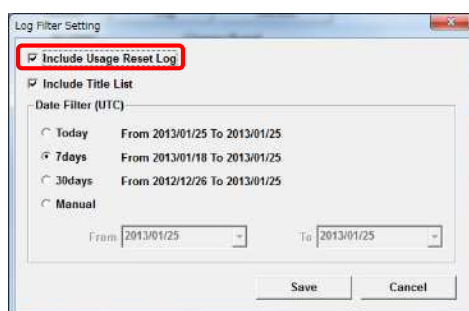
1-5. DCC-Save information-Include Usage Reset Log

Change the default setting to “check on” as below.

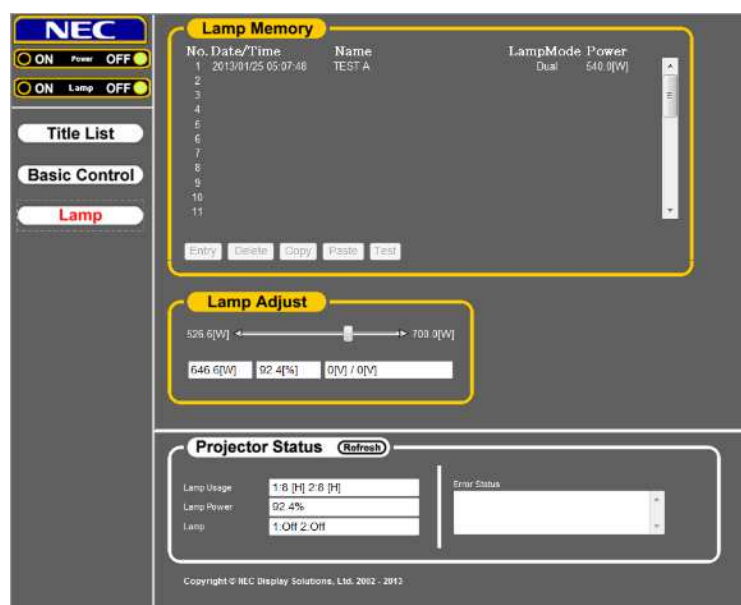
NC900C HTTP Server menu

HTTP Server supports Lamp Memory, Lamp Adjustment, and Bulb Alignment(*).

(*)Bulb Alignment is available for NC1200C/NC2000C/NC3200S/NC3240S.

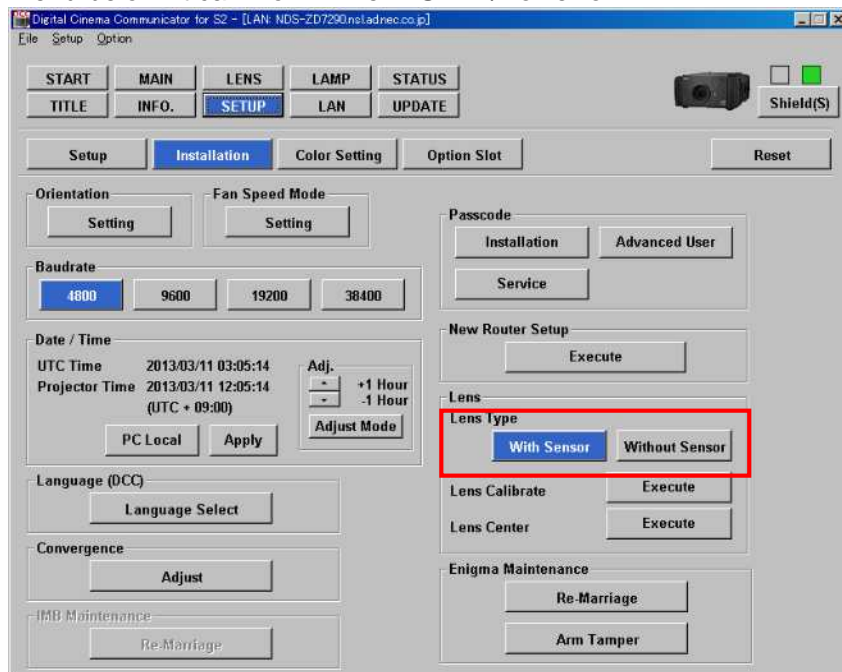
DCC menu (*1)

1) When you change lens, you should setup lens type setting through either of DCC or LCD menu below. It can work while in STBY/Power-on.

(*1) Need to enter installation mode or higher on DCC.

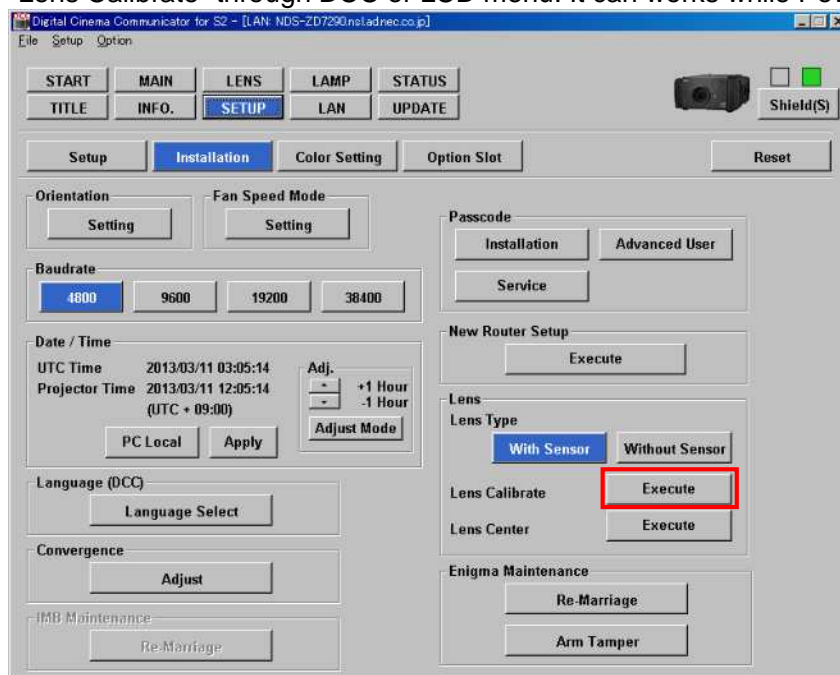
DCC menu

2) When you attach lens with sensor, make sure that lens type is “With sensor”. Then do “Lens Calibrate” through DCC or LCD menu. It can works while Power-on only.

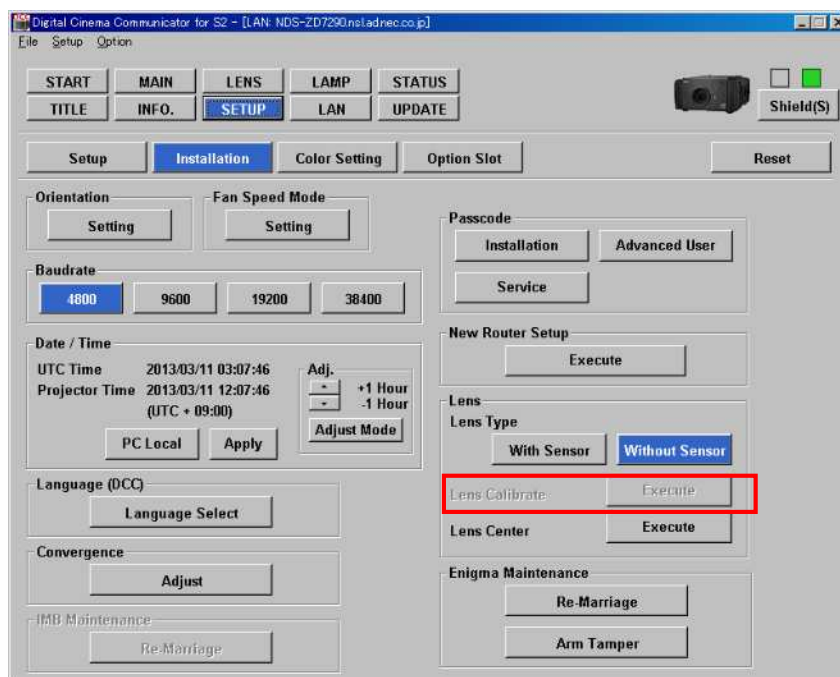
DCC menu

1. If you setup <Without Sensor> as Lens Type, Lens Calibration feature can not work like below.

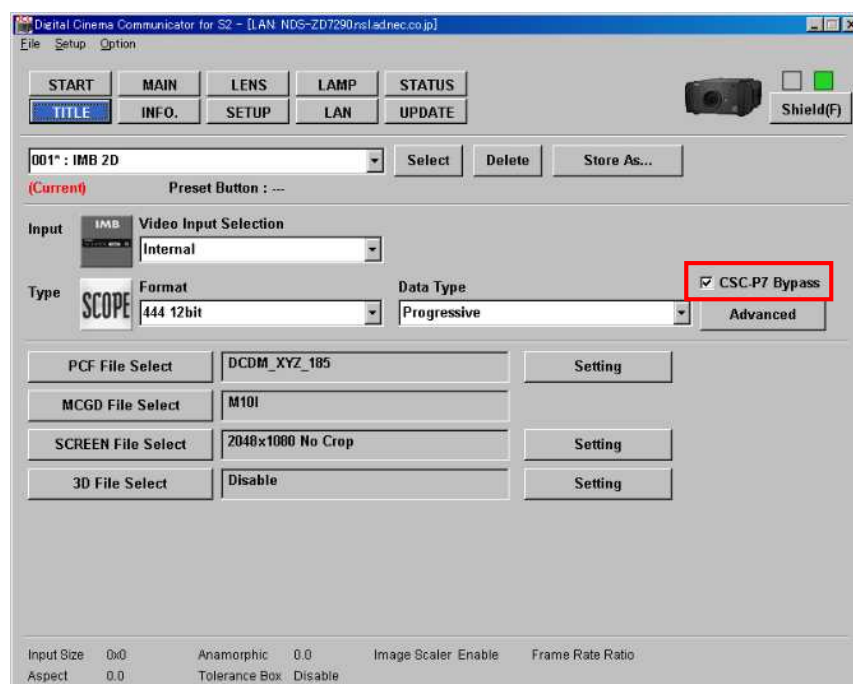
If you want to get native color, check on "CSC-P7 Bypass". (*)

<input type="checkbox"/> CSC-P7 Bypass	(Off)	Enabled CSC-P7 correction.(Default)
<input checked="" type="checkbox"/> CSC-P7 Bypass	(On)	Disabled CSC-P7 correction.

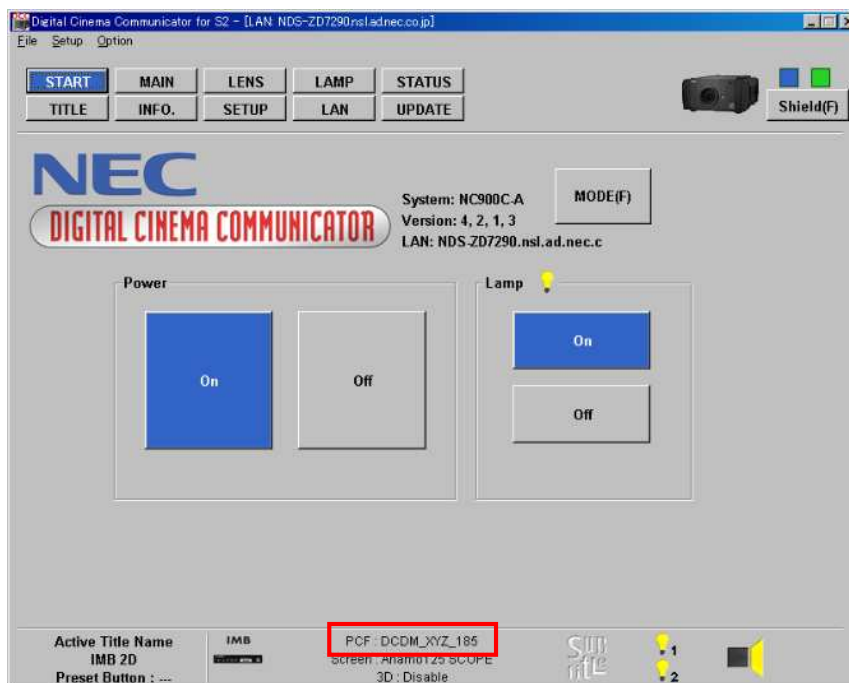
1. LUT-CLUT, LUT-DG can not be disabled in this function.
2. While "CSC-P7 Bypass" is check on, user can configure PCF/MCGD setting. However, color correction is disabled.(CSC-P7 hardware is disabled).
3. While "CSC-P7 Bypass" is check on, PCF file name corresponding to the current title shows up on DCC like below.

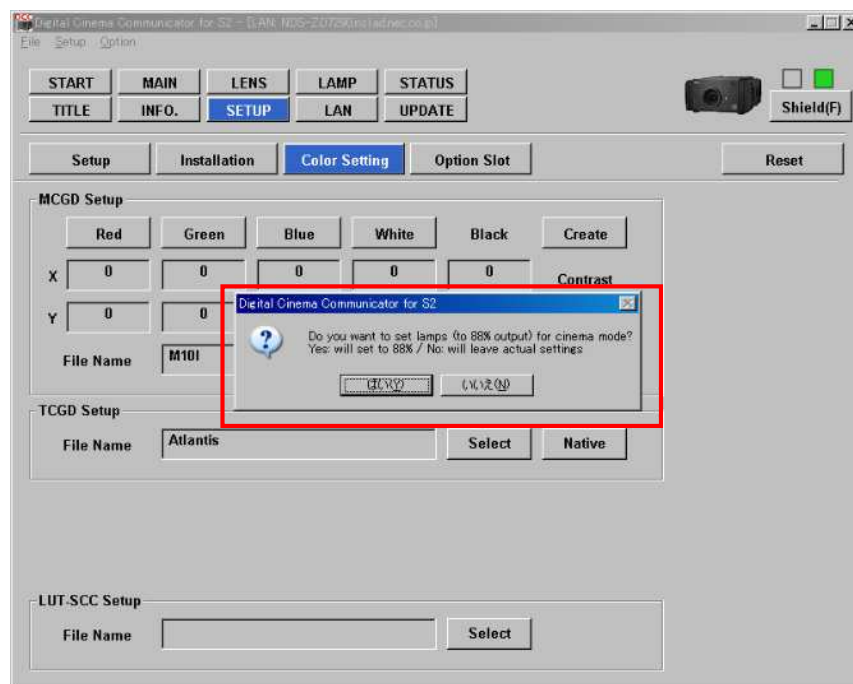
If you click on [Yes], then projector will set 88% brightness automatically. And message is stored in operation log like below.

If brightness sets to 88% by this feature, the next message is stored in operation log.
