This document describes new features, improvements, bug fixes, and other information for the Dolby® Atmos™ Cinema Processor CP850.

System 2.1.0.10 – Patch Release for system 2.0.

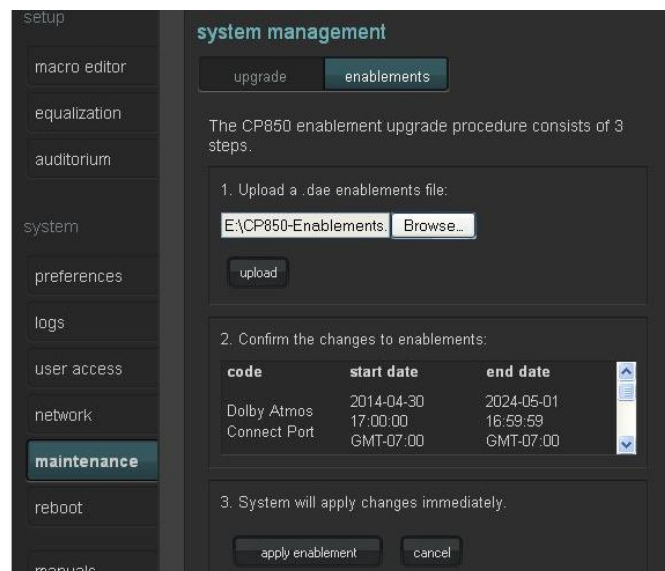
7. When the CP850 boots up, it will check the enablements of the unit and the system configuration file. If the enablement status does not permit the loading of the system configuration, the mute button will repeatedly blink red and no audio will be heard. A separate enablements key can be provided by Dolby Customer Support. Load the enablements using the Web GUI:

“Fully Featured” CP850s sold to this point will receive the three Enablement licenses for these features at no cost. The enablements file (*.dae) for all units in the field is included in the installer file and will be automatically loaded during the upgrade. There should be no need for the user to load the enablements manually.

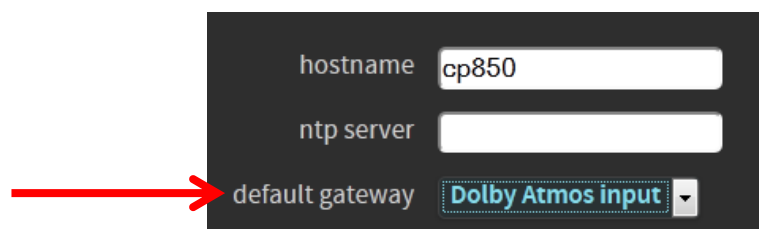
8. In previous versions of CP850, the user was allowed to set a default gateway on each of the two networks. This caused issues with some networks. Version 2.x of CP850 only allows one default gateway to be active. By default, COMMAND network is set as the active default gateway. The setting can be changed to the DOLBY ATMOS INPUT network through the Web GUI or front panel user interface.
