Dolby IMS3000 Software Bundle v3.5.20 Release Notes

January 2024 8800122 Issue 15

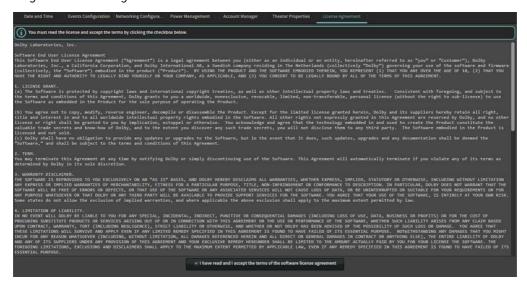
Figure 1: License agreement

- 1. After you log in to the Dolby IMS3000 web UI, click **Setup & Maintenance**, click **System Settings**, and then click **Licenses**.
- 2. Scroll down, read the license agreement, and then select I have read and accept the terms of the software license agreement.
